**DOT/FAA/AR-99/20, P1**

# **Development of a Supplemental Inspection Document for the Fairchild SA226 and SA227 Aircraft, Part 1**

Technical Report

14. Sponsoring Agency Code  ACE-100	
15. Supplementary Notes  The FAA William J. Hughes Technical Center manager was Mr. Xiaogong Lee.			
16. Abstract  This report is the first phase of a three-phase program sponsored by the Federal Aviation Administration to develop a supplemental inspection document for Fairchild SA226 and SA227 aircraft. In this report, the mission profiles for the aircraft are established. The principal structural elements are defined, and the operating stresses are established.

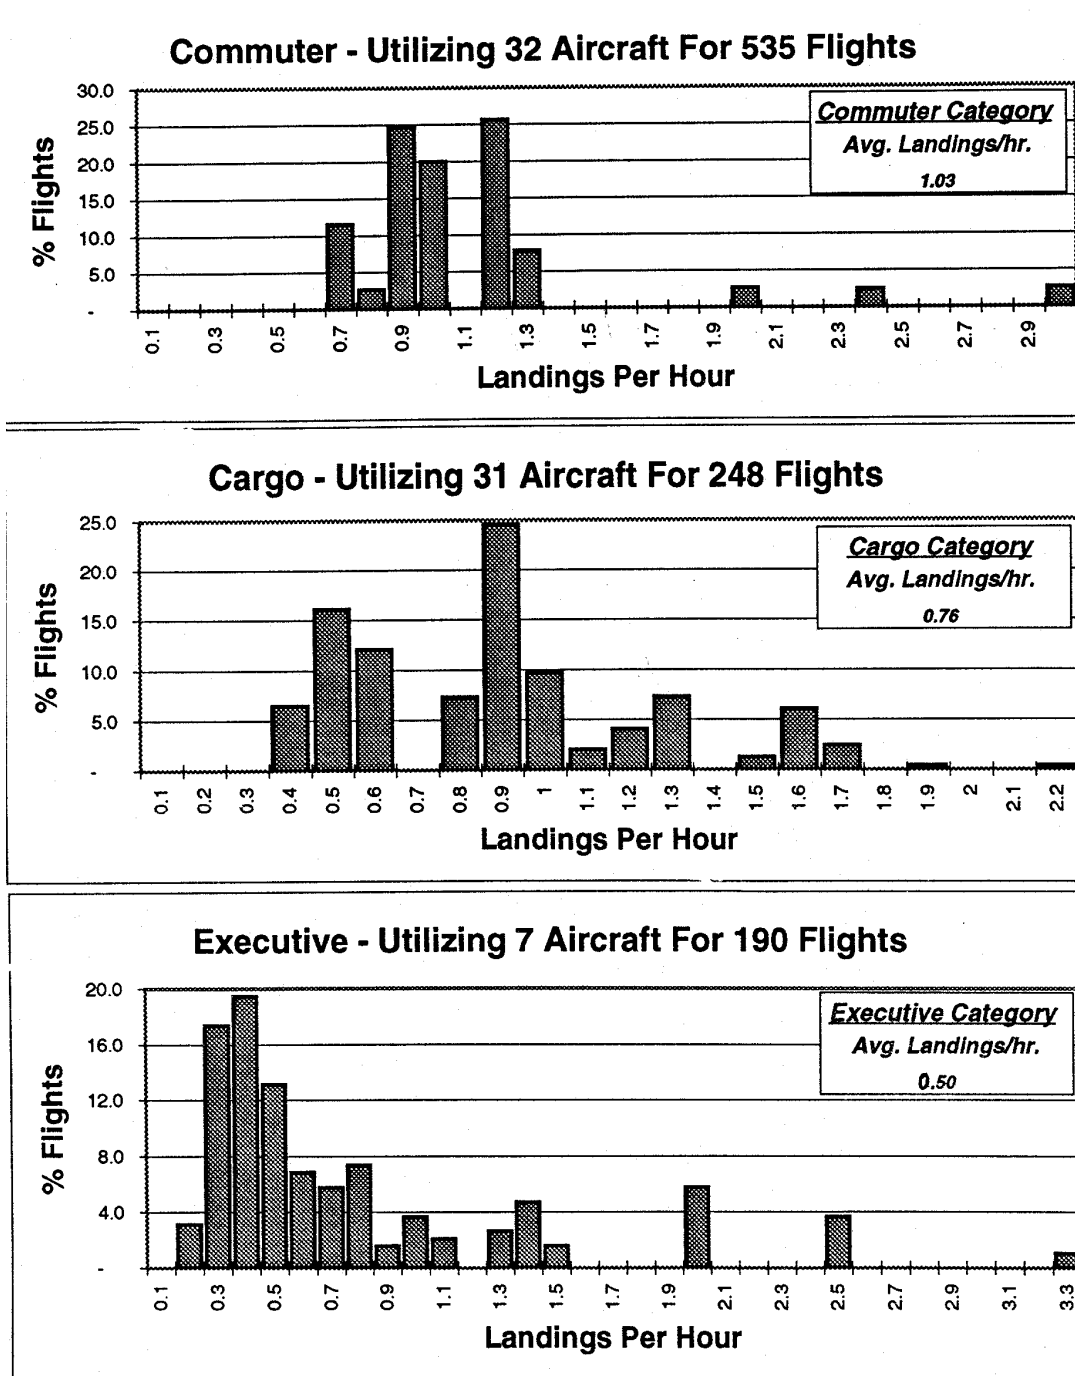
**FIGURE 2-1 LANDING FREQUENCY COMPARISON**

Figure 2-1 shows histograms of the three operation categories illustrating the number of flights vs. landings per hour.

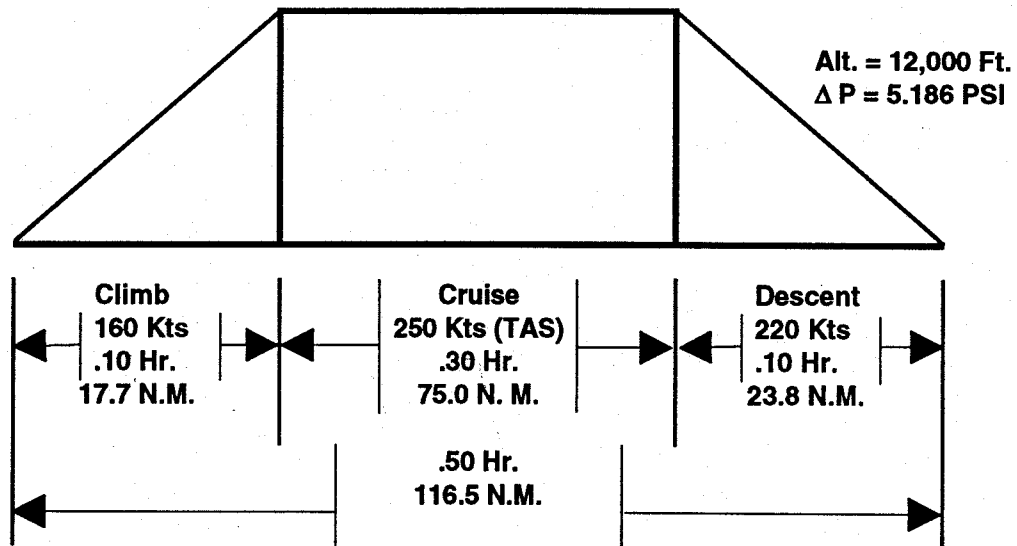
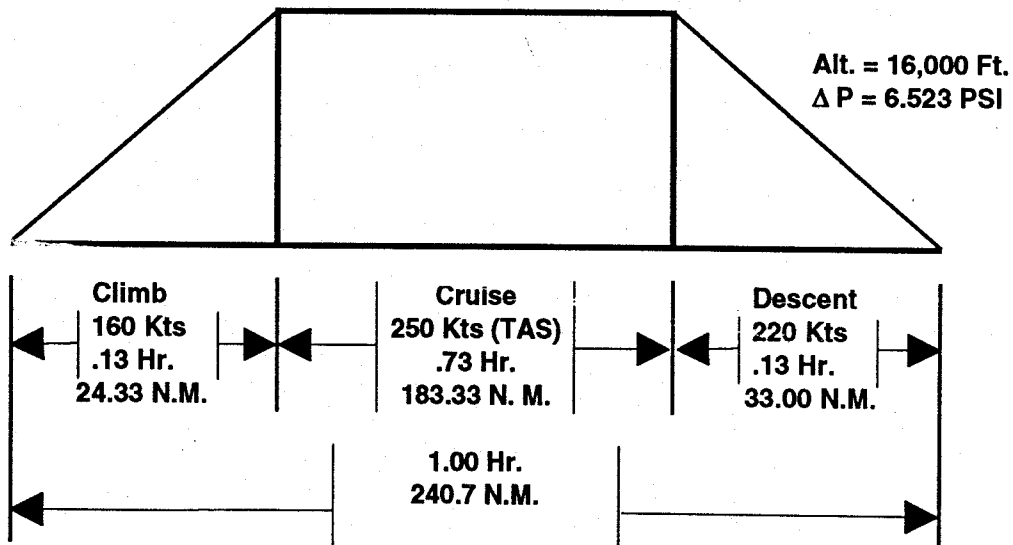
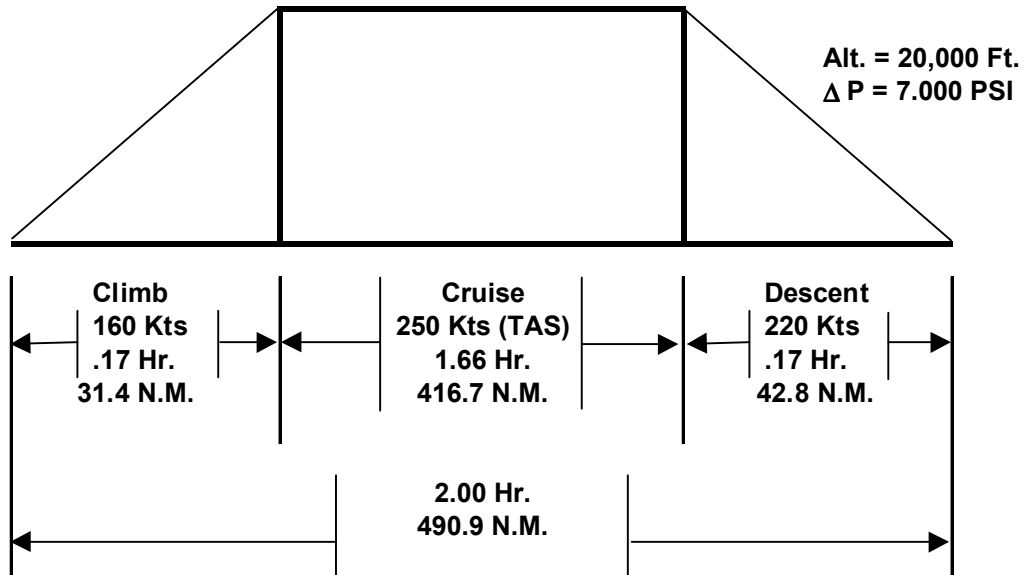
FIGURE 3-1 FLIGHT PROFILE ILLUSTRATION

**Figure 3-1 FLIGHT PROFILE ILLUSTRATION (Continued)**

Flight Profile Group	Flight Length (Minutes)	Cruise Altitude (Feet)	Takeoff Gross Wt. (Lb)	Landing Weight (Pounds)	Climb Speed (Kts)	Descent Speed (Kts)	Cruise Speed (Kts)
Combined Profile	30	20,000	13,800	13,000	160 (IAS)	220 (IAS)	250

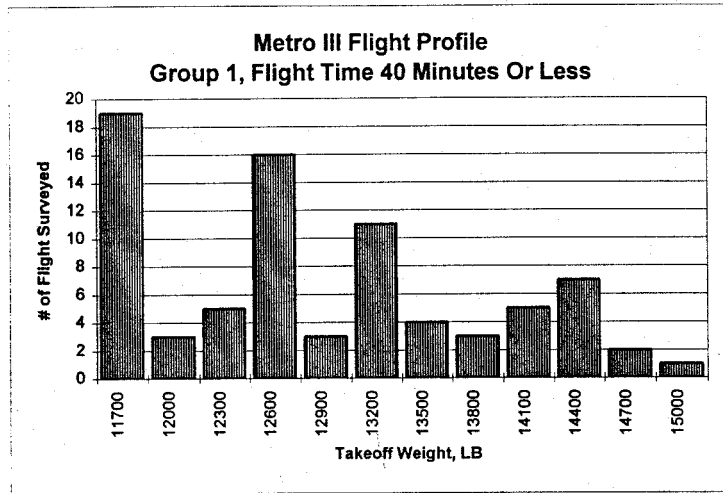
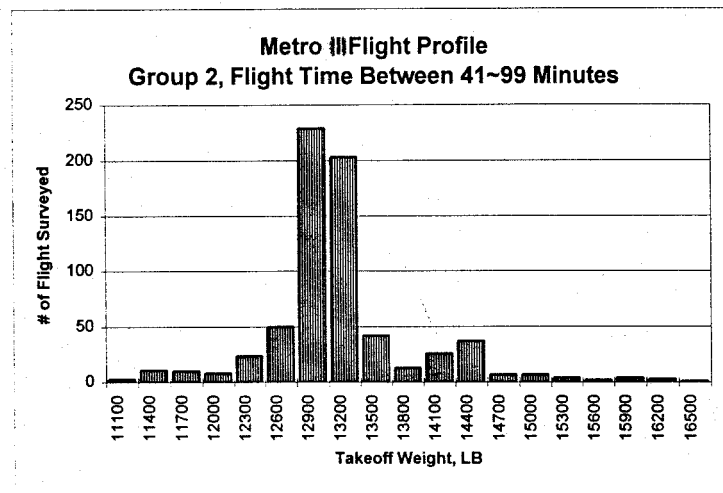
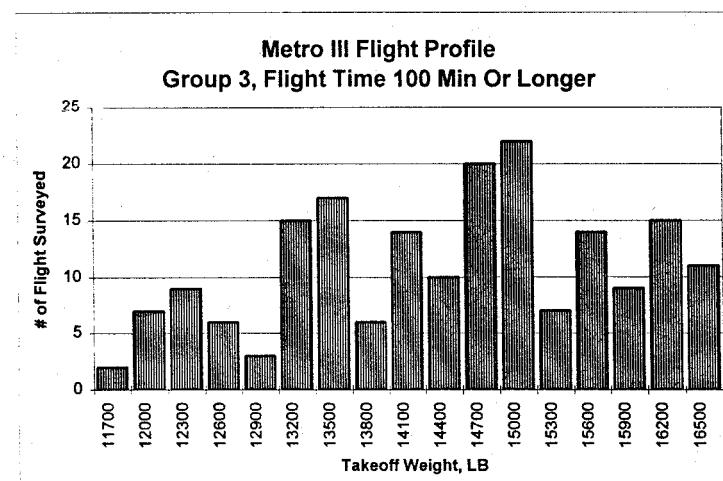
**FIGURE 3-2 FLIGHT PROFILE - FLIGHT LENGTH**

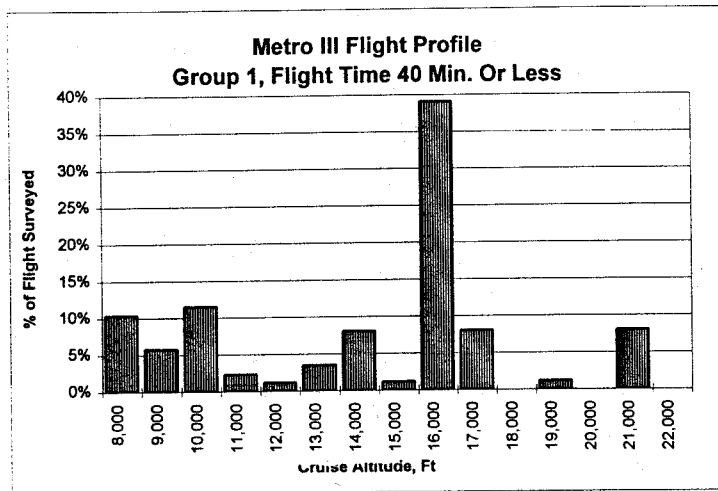
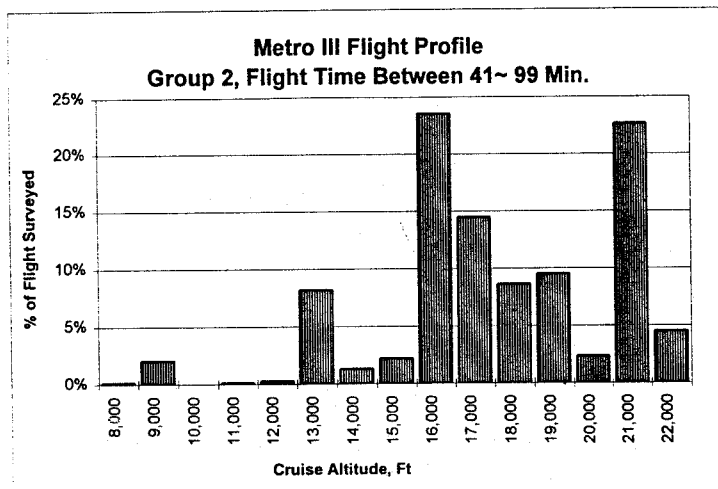
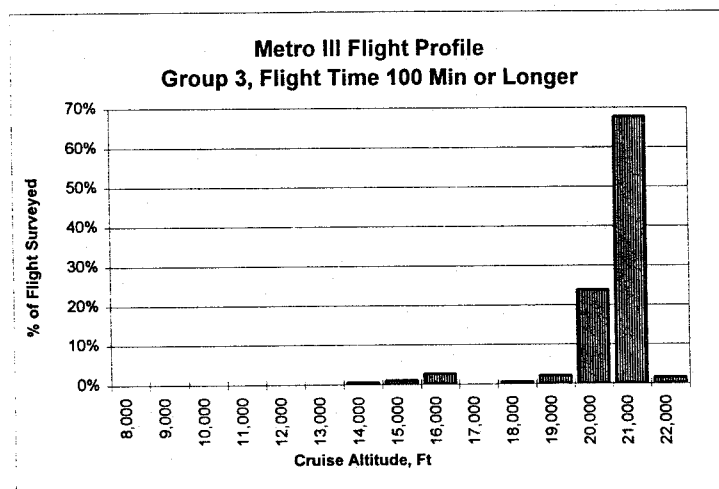
**FIGURE 3-3 FLIGHT PROFILE - CRUISE ALTITUDE**

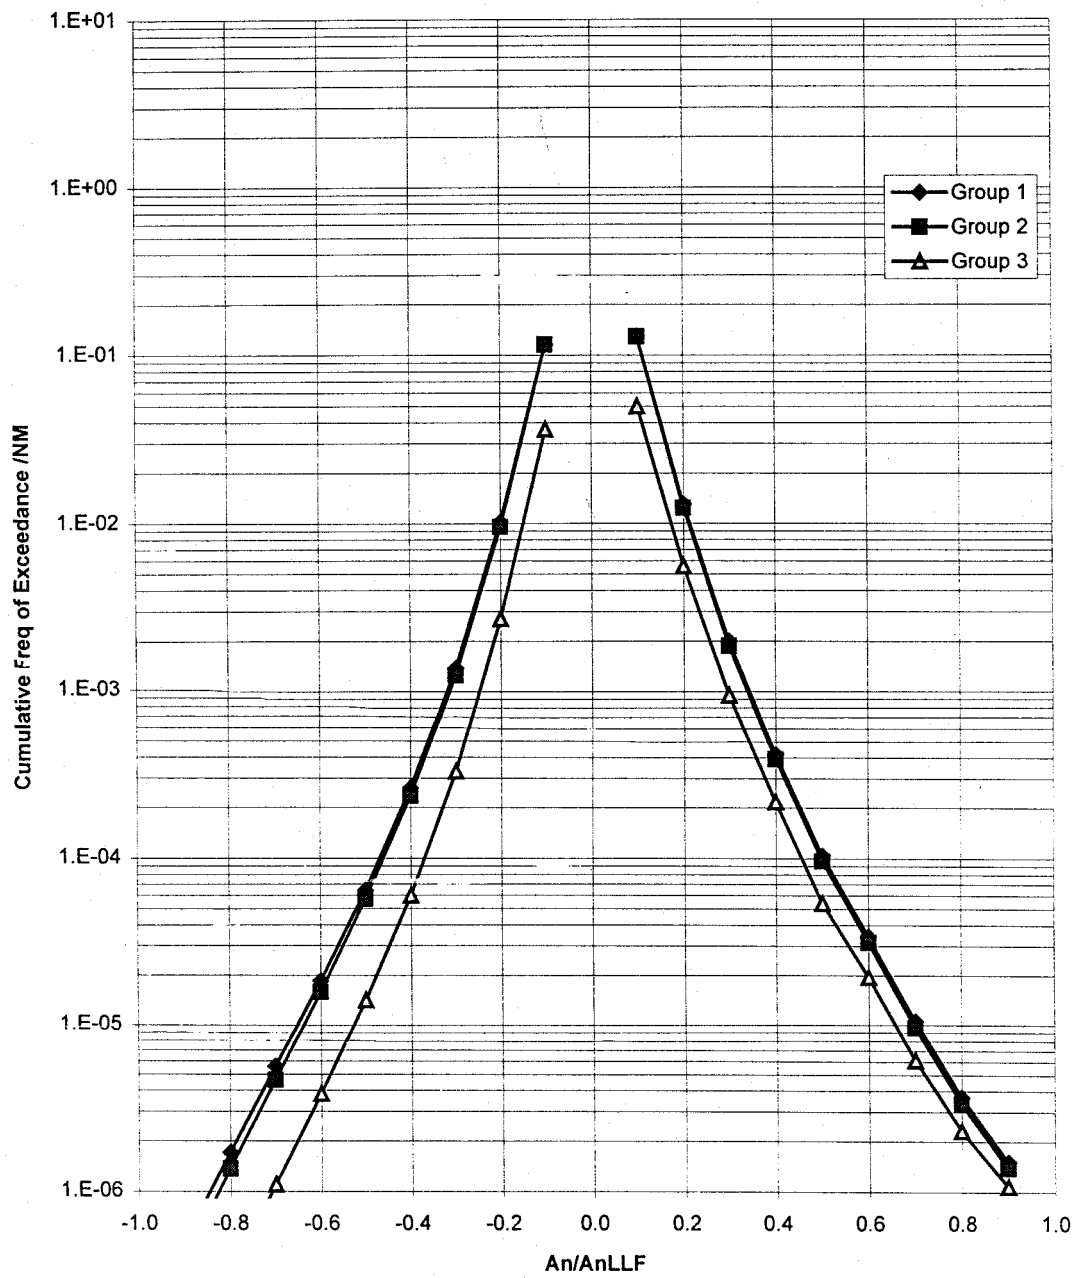
FIGURE 4-1 SA227 MANEUVER AND GUST SPECTRUM

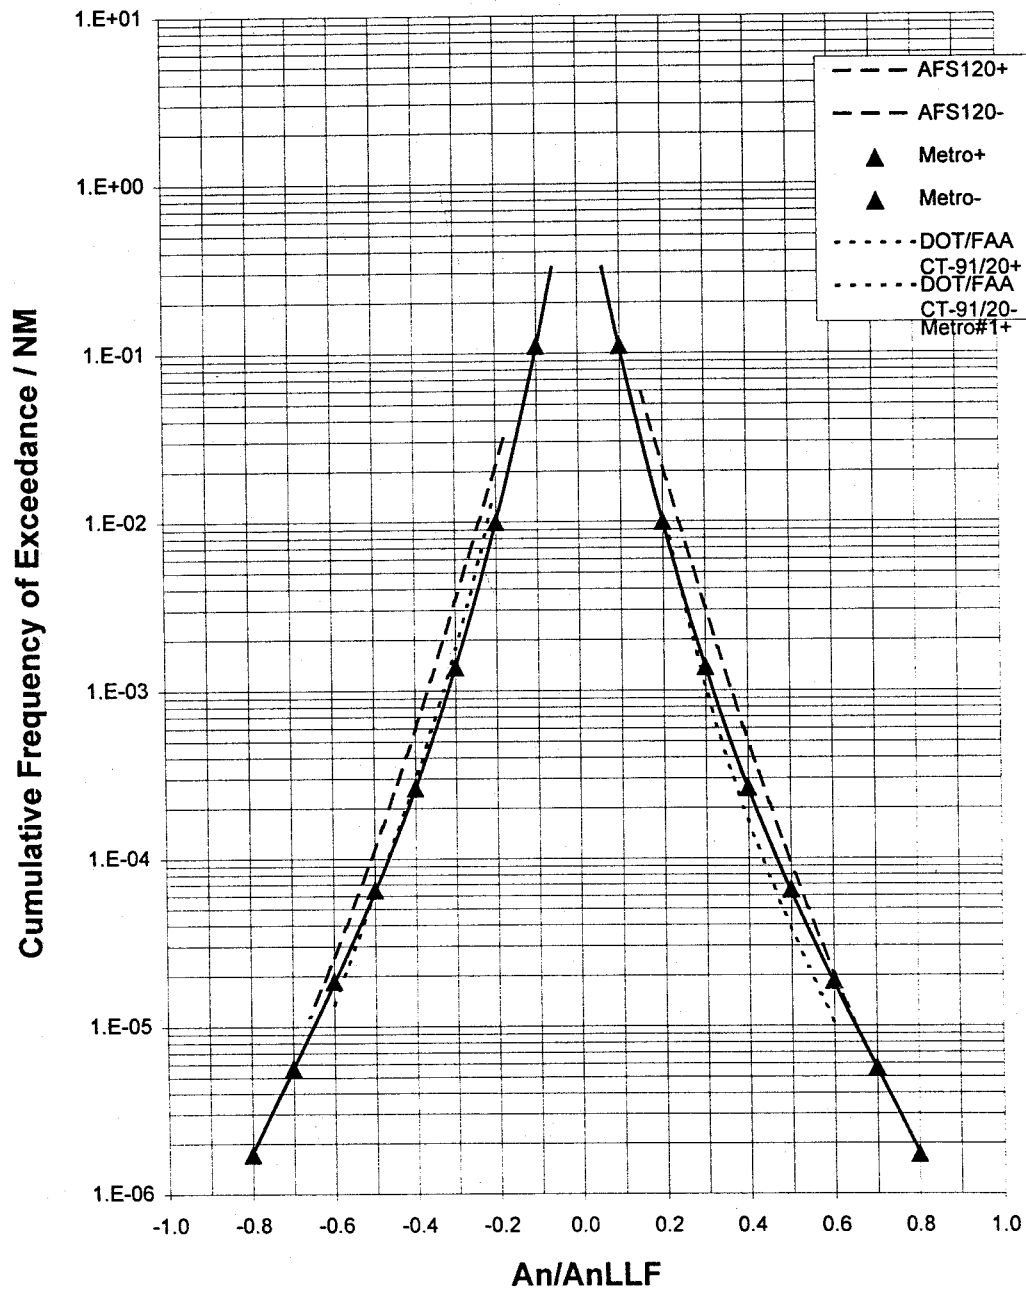
**FIGURE 4-2 GROUP 1 FLIGHT PROFILE  
 VERTICAL GUST LOADS EXCEEDANCE COMPARISON**

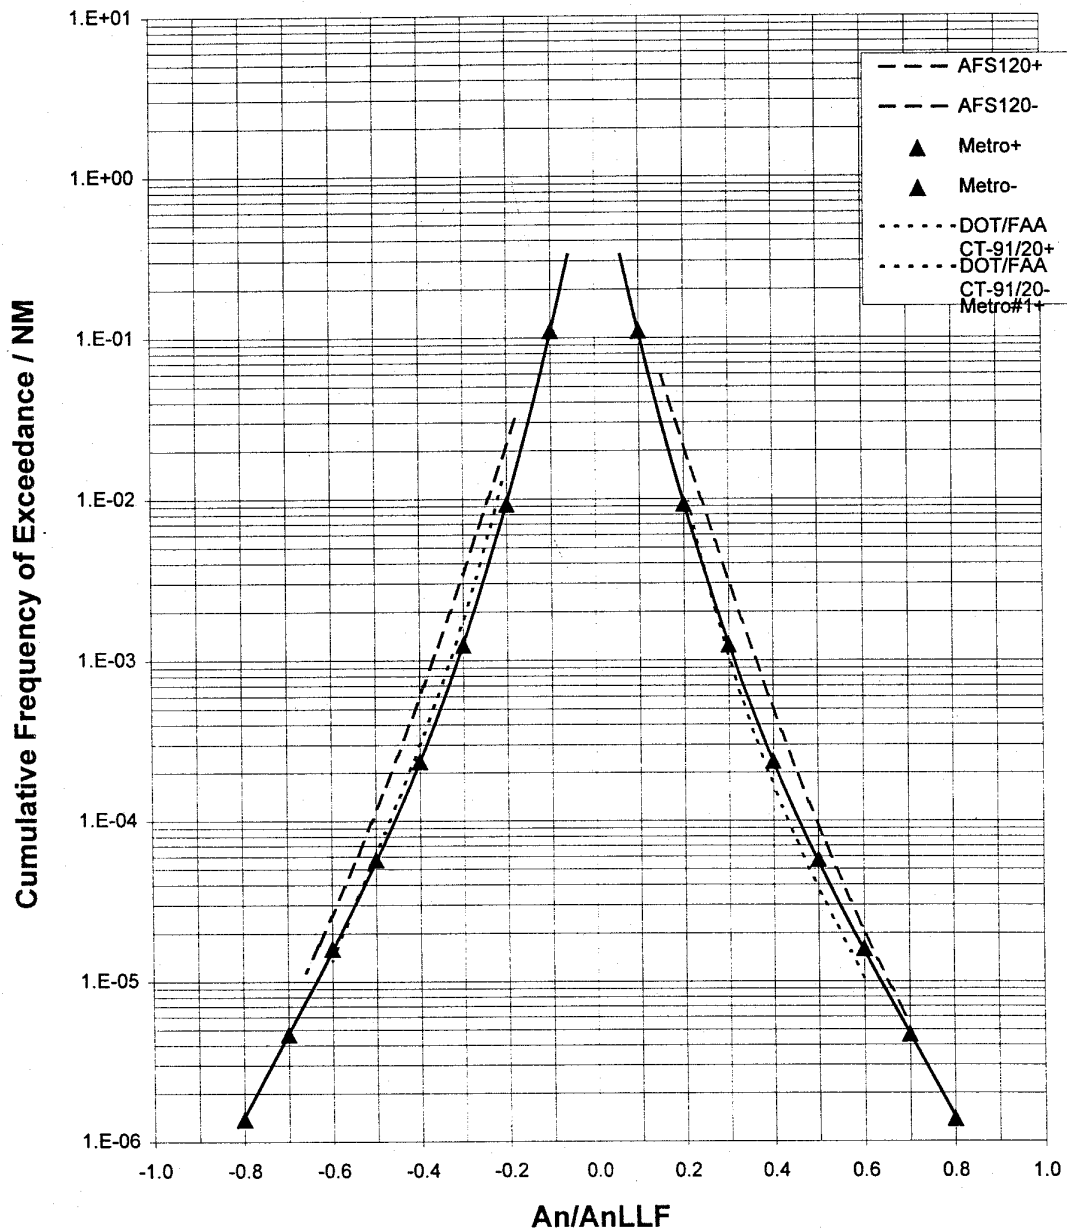
**FIGURE 4-3 GROUP 2 FLIGHT PROFILE  
 VERTICAL GUST LOADS EXCEEDANCE COMPARISON**

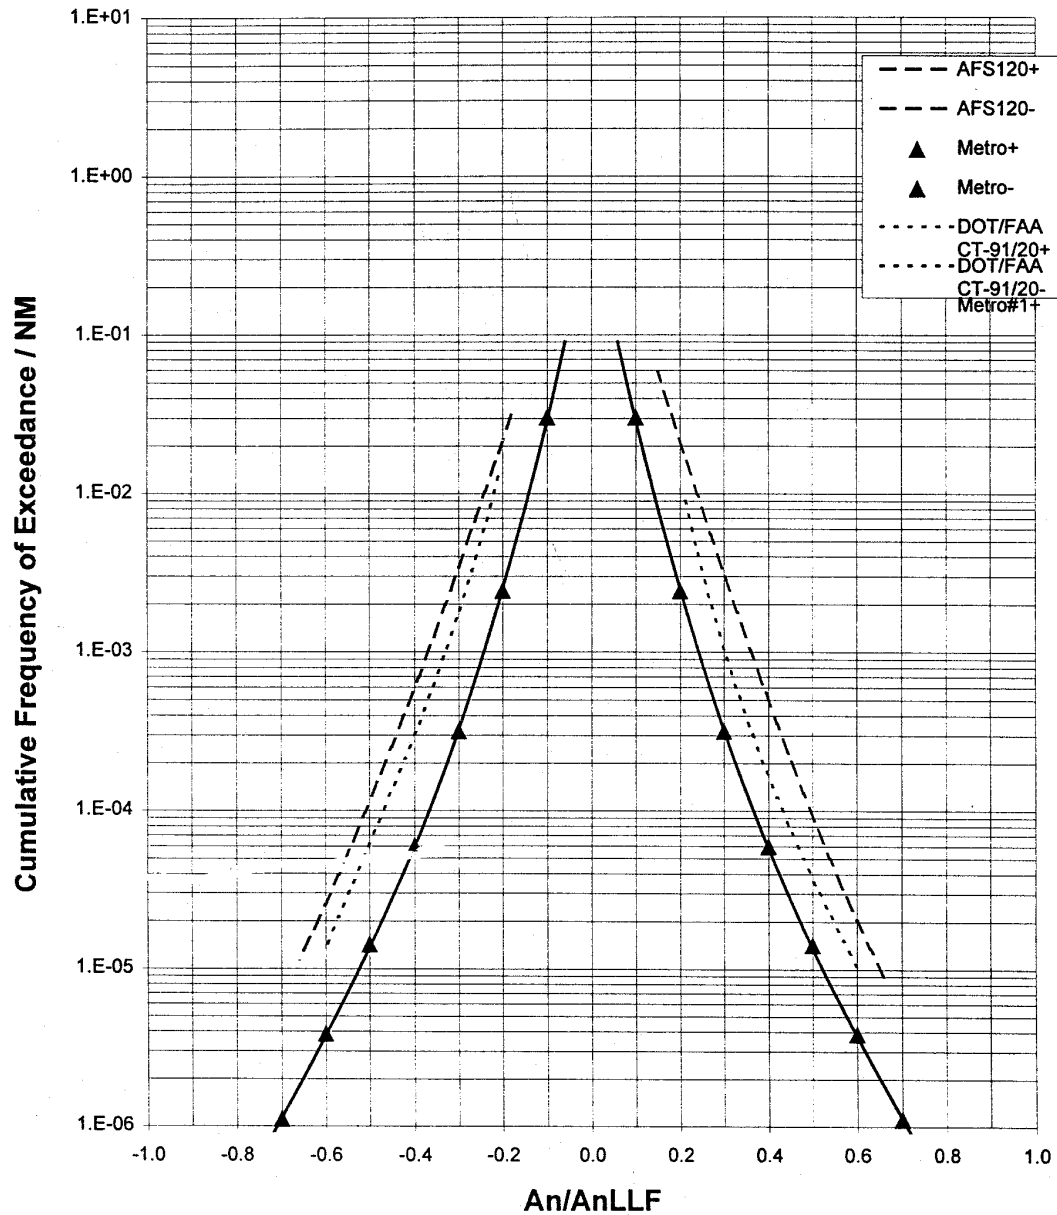
**FIGURE 4-4 GROUP 3 FLIGHT PROFILE  
 VERTICAL GUST LOADS EXCEEDANCE COMPARISON**

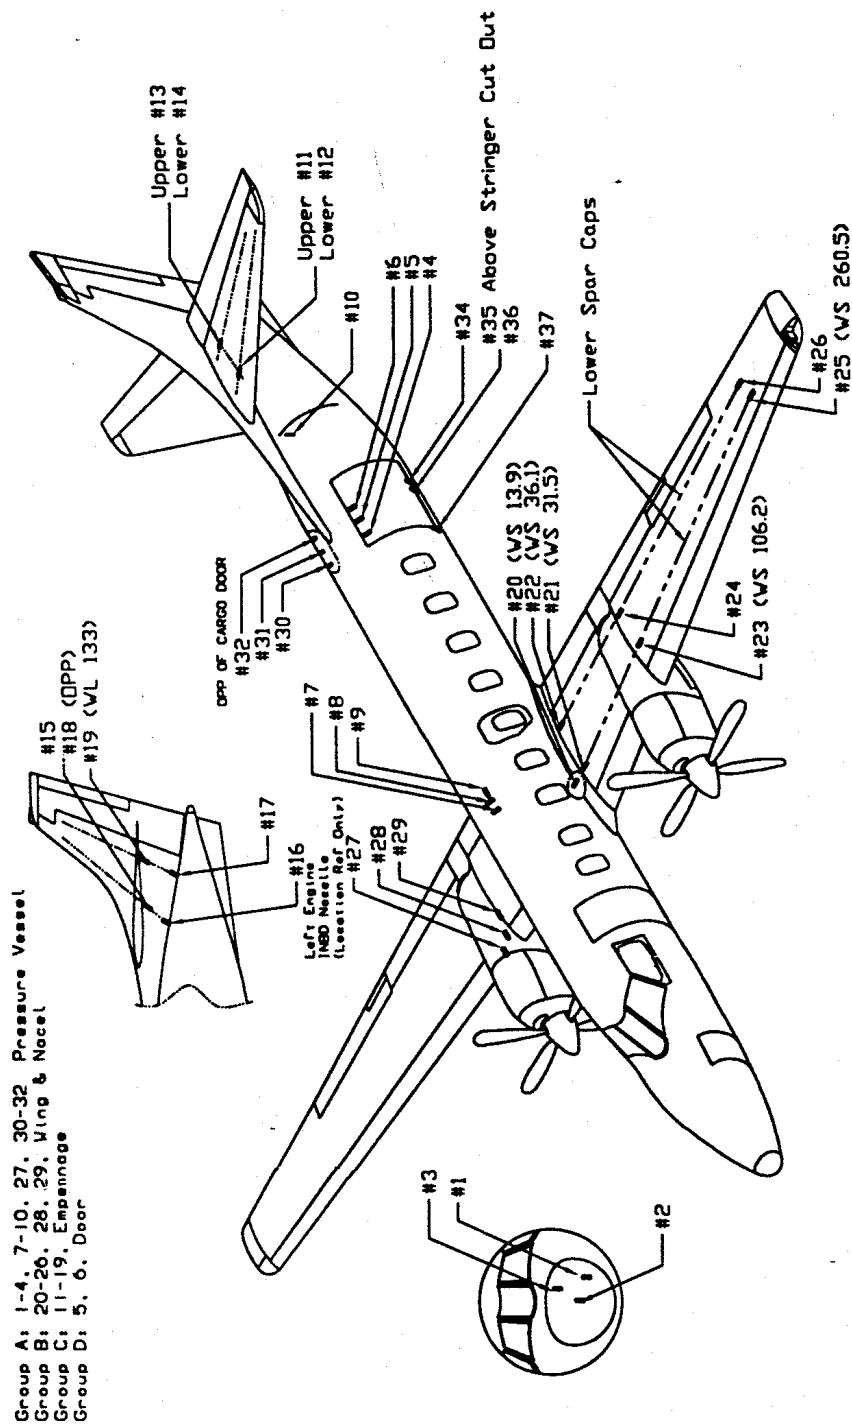
FIGURE 5-1 STRAIN GAGE LOCATIONS

A model SA227 DC aircraft serial number AC-557 was instrumented to measure strains at selected locations on the aircraft during typical flight maneuvers. A total of five flights were made to collect the data preceded by a calibration of the aircraft strain gages by the application of known loads to the aircraft. The location of the strain gages is shown on Figure 5-1.

Strain gages were located at three locations on the wing main and rear spar, on the horizontal tail main spar and rear spar near the root, and on the main and rear spar of the vertical tail. In addition strain gages were located at potentially high stress locations on the pressure vessel and nacelle. The strain gages were loaded with known loads to verify the gages were functioning properly. The data were recorded on the hard disk of a PC on the aircraft by a virtual instrument developed using LabView for Windows software. The analog to digital boards on the aircraft are capable of recording voltages equivalent to about 40-psi stress. For this reason some of the plots discussed are somewhat ragged looking when displaying very low stress levels.

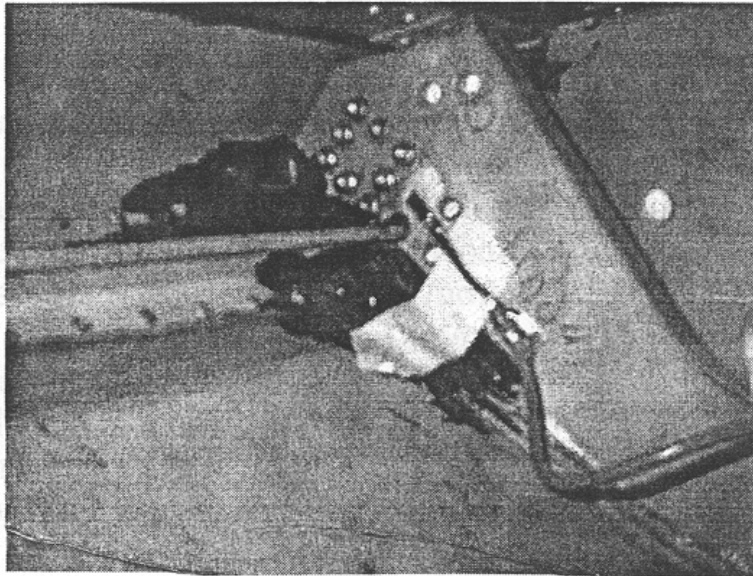
**FIGURE 5-2 STRAIN GAGE 34**

Four additional gages were mounted in the fuselage cargo door surround structure to measure stresses at the latches due to pressurization. The location of these gages is

shown in Figure 5-2 through Figure 5-4. The stresses measured by these gages are shown in Appendix D of reference 20.

The stress measured at gage 34 was in reasonable agreement with the calculated stress. The stress at gages 35 and 36 was unexpected and did not match the stresses which caused fatigue cracks at this location during the full-scale fatigue test. After the crack was discovered during the fatigue test, the frames at this location were increased in thickness from 0.040 to 0.071 inch the local lightening holes were removed, and the tooling holes were plugged. The new configuration is the one being used in the current test. These changes are not expected to change the sign of the local stresses. The compressive stresses now measured locally may be due to variations in the local engagement of the latches that would vary from aircraft to aircraft. For this reason any analysis must assume the maximum calculated stress in these frames.

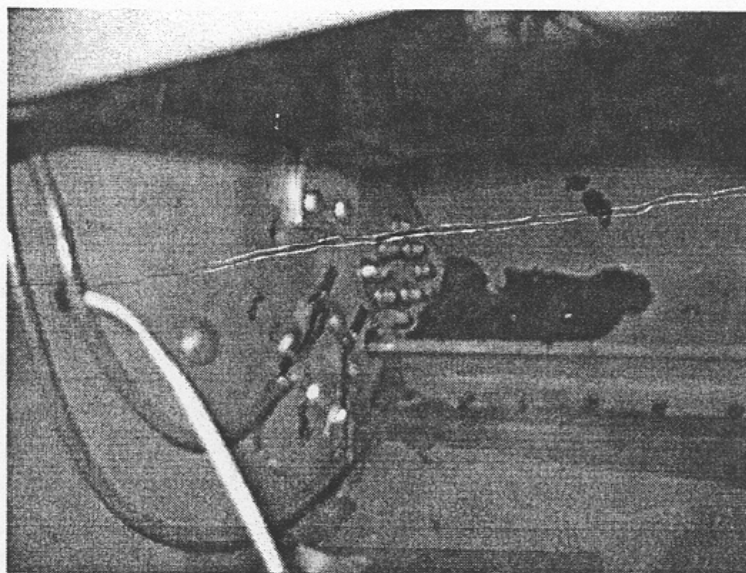
**FIGURE 5-3 STRAIN GAGE 35, 36**

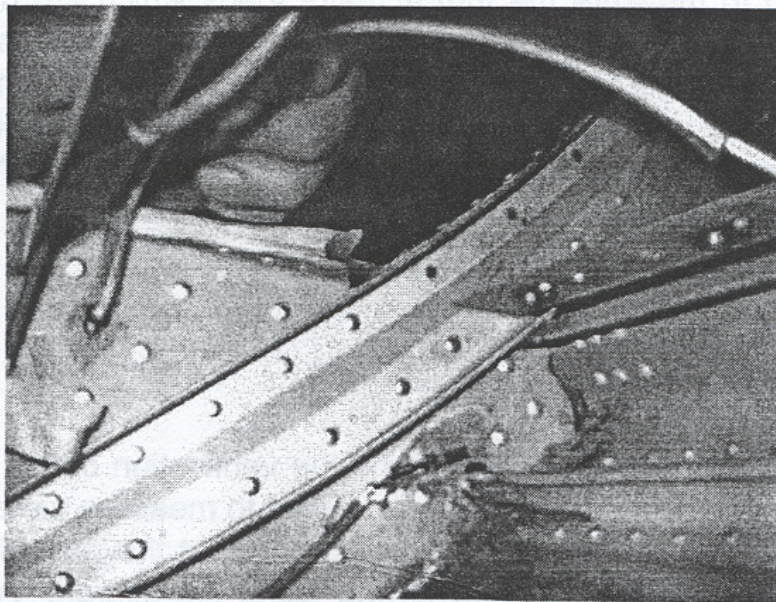
**FIGURE 5-4 STRAIN GAGE 37**

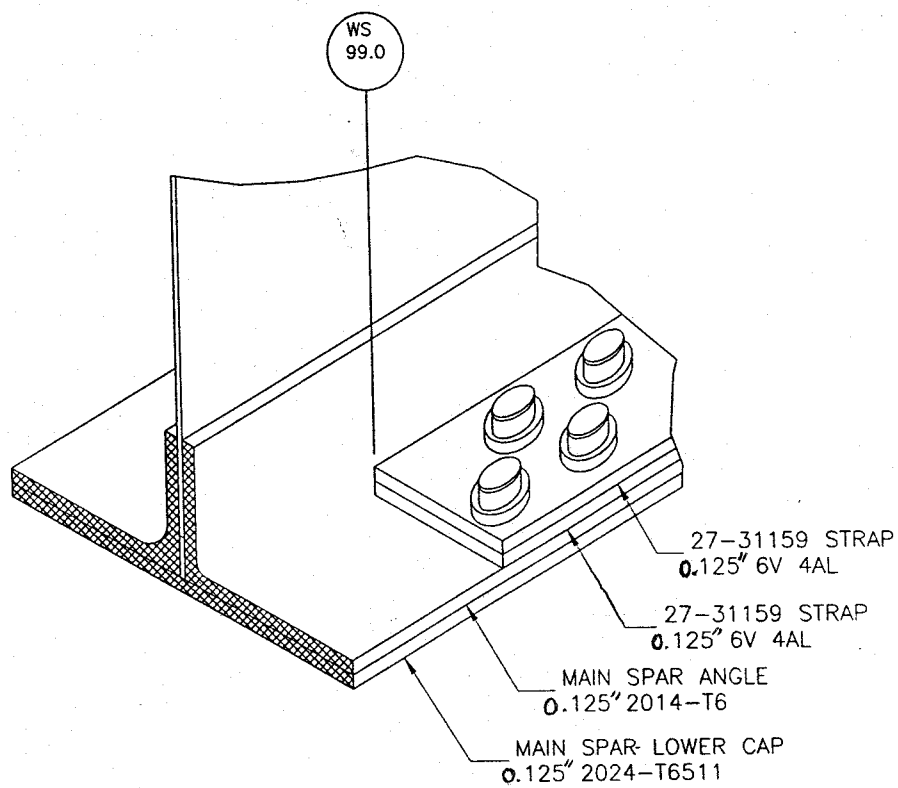
9. Inspect	Difficult to inspect. Look for crack on exposed center ridge of spar cap.	a	11
Total Score			64

**FIGURE 6-1 W1 - SA226 MAIN SPAR LOWER CAP AT WING  
STATION 99.0**

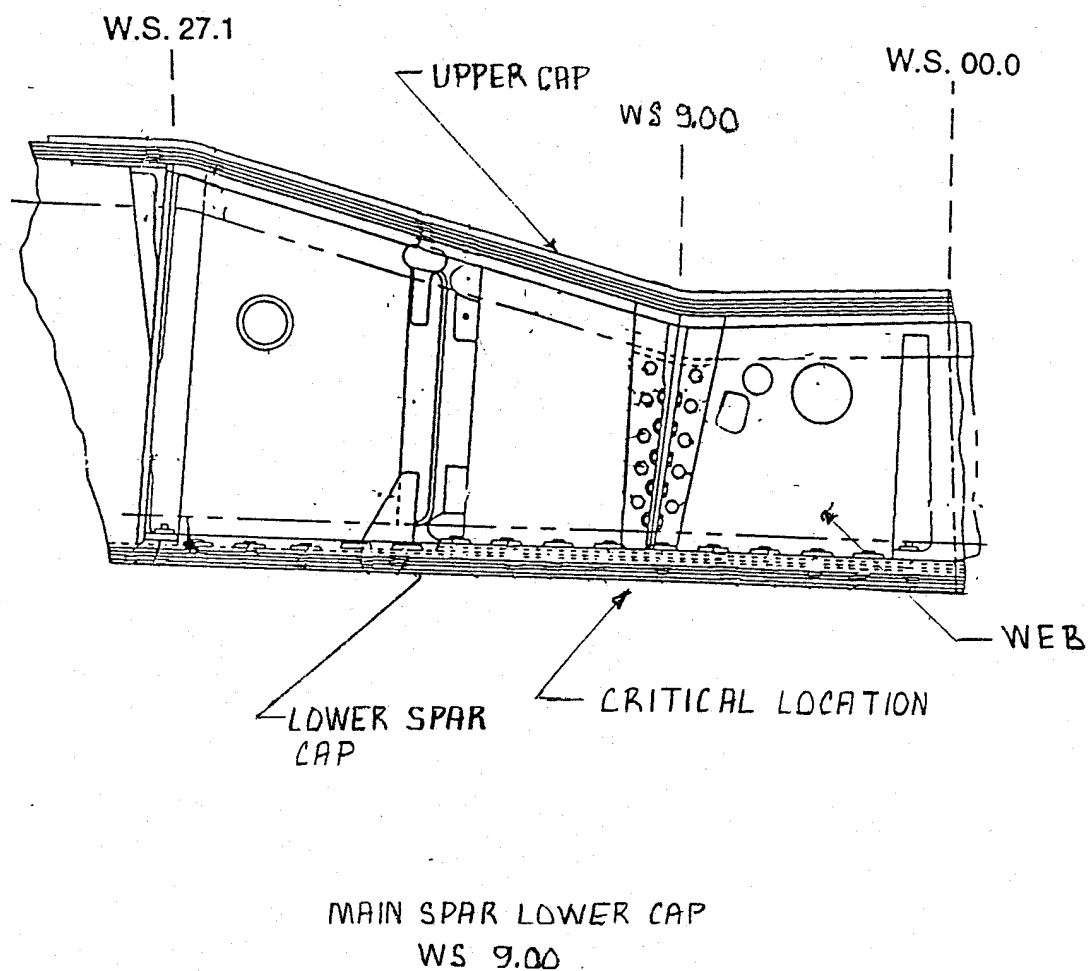
7. K <sub>t</sub>	Minor local bending.	c	3
8. Accidental Damage	Low probability of damage. Away from propellers and baggage and service vehicles.	d	2
9. Inspect	Difficult to inspect. Look for crack on exposed center ridge of spar cap.	a	11
Total Score			58

**FIGURE 6-2 W2 - SA226 MAIN SPAR LOWER CAP AT WING STATION 9.0**

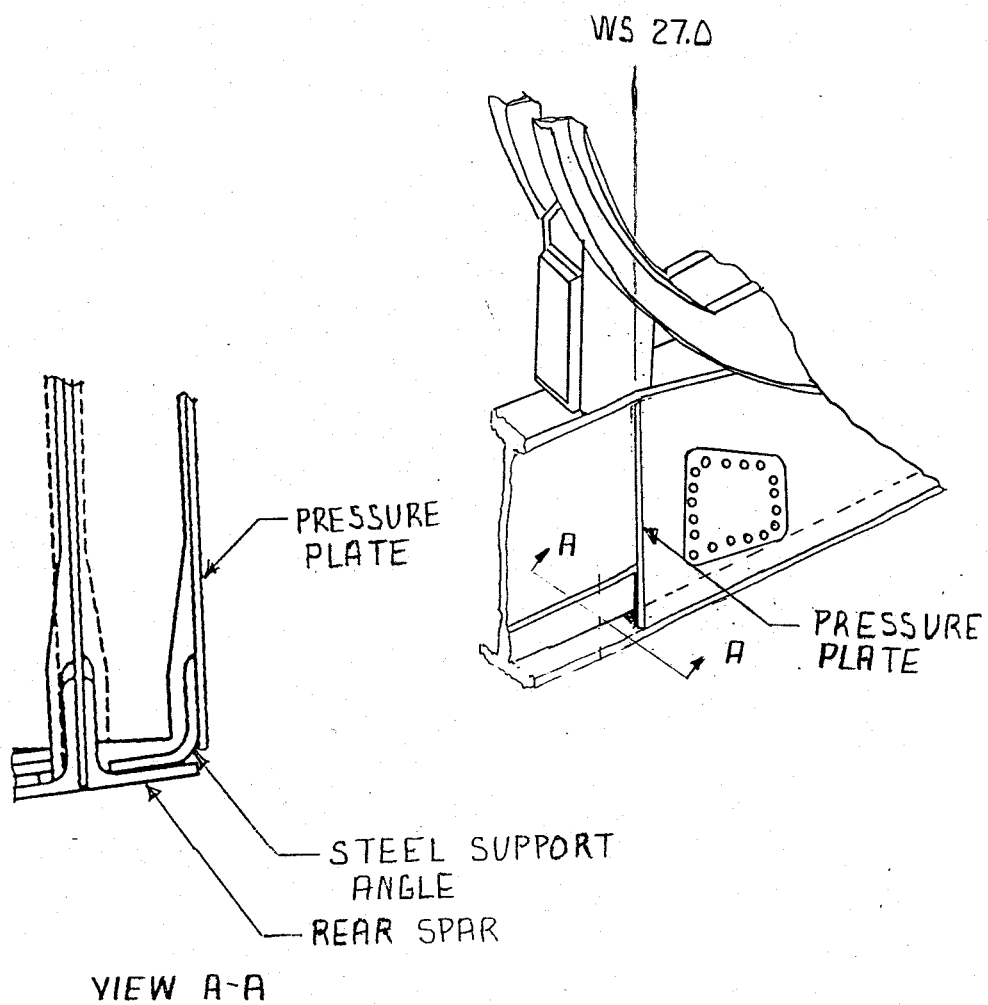
9. Inspect	Difficult to inspect. Modification may be needed.	a	12
Total Score			60

**FIGURE 6-3 W3 - SA226 REAR SPAR LOWER CAP AT WING STATION 27.0**

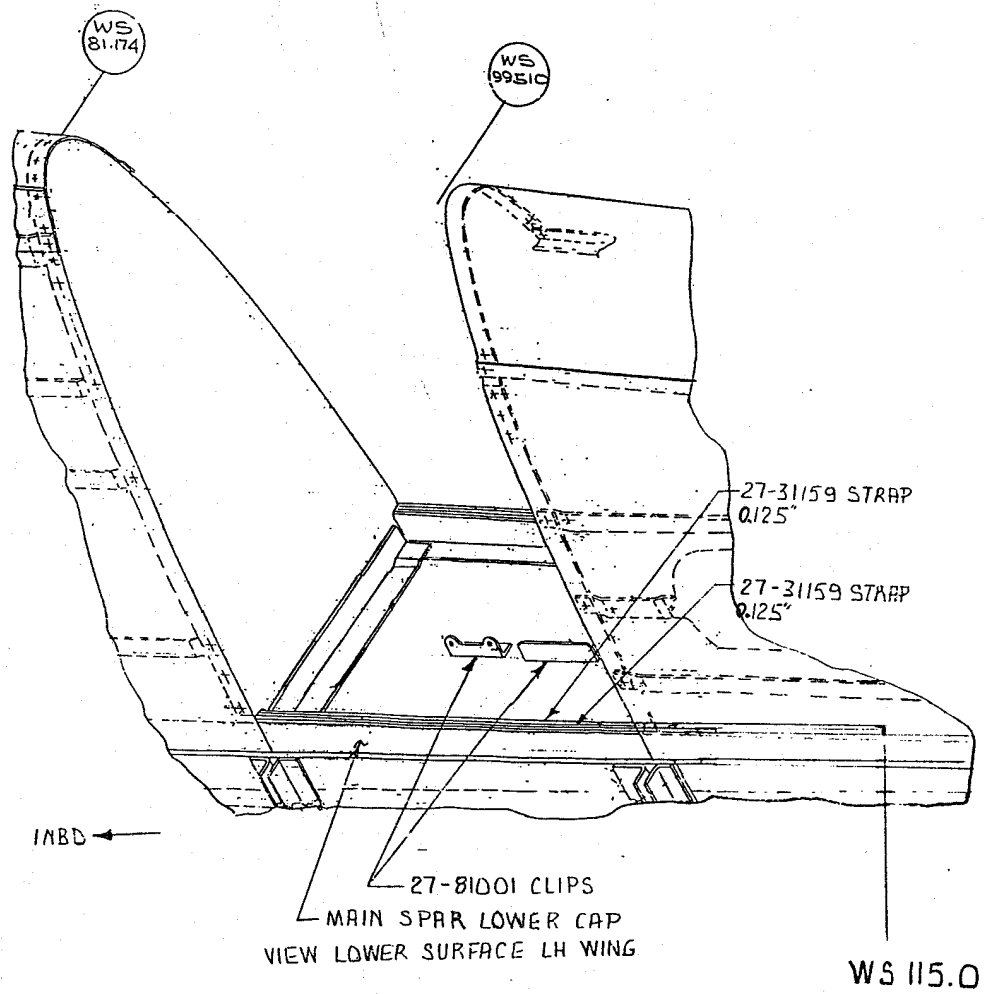
9. Inspect	Difficult to inspect.	a	12
Total Score			63

**FIGURE 6-4 W4 - SA227 MAIN SPAR LOWER CAP AT WING STATION 99.0**

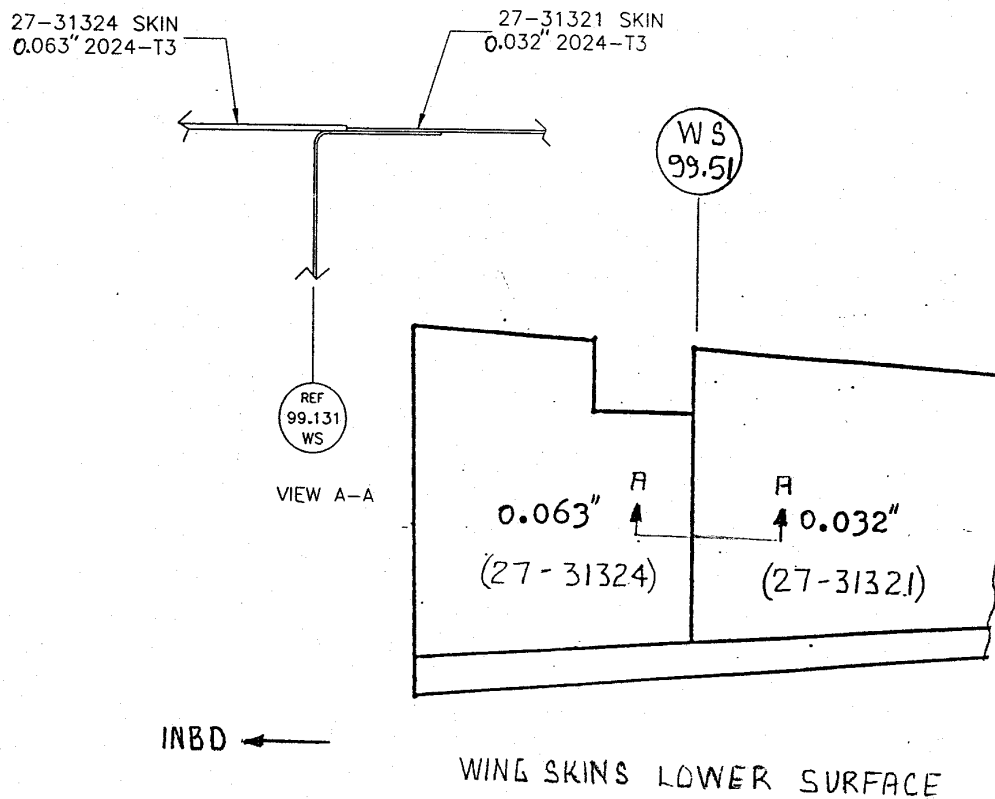
9. Inspect	Difficult to inspect directly. Look for fuel leaks.	d	4
Total Score			55

**FIGURE 6-5 W5 - SA227 SKIN SPLICE AT WING STATION  
99.51 LOWER SURFACE**

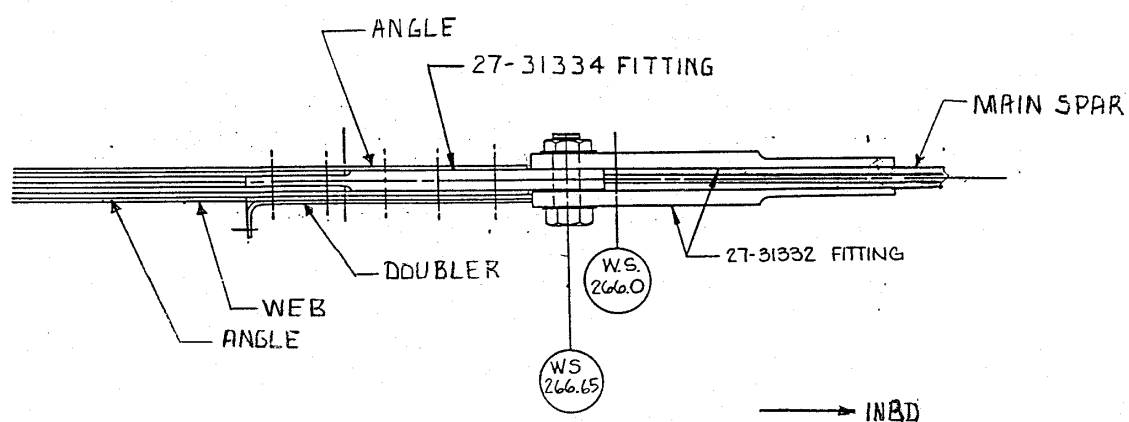
9. Inspect	Difficult to inspect directly. Remove skin panel.	c	6
Total Score			44

WING EXTENSION FITTING MAIN  
SPAR LOWER SURFACE  
VIEW LOOKING FWD

**FIGURE 6-6 W6 - SA227 WING EXTENSION FITTING MAIN  
SPAR LOWER SURFACE**

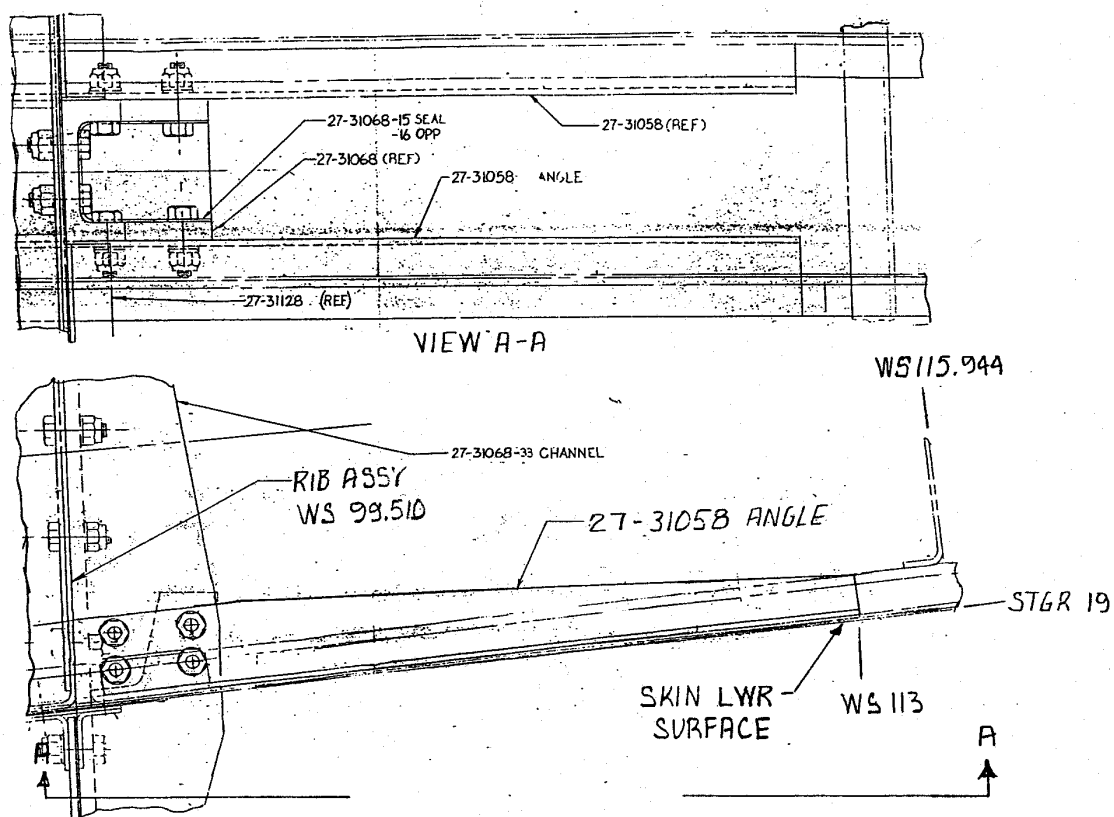
9. Inspect	Walk around inspection will spot fuel leak.	e	2
Total Score			39

**FIGURE 6-7 W7 - SA227 LOWER WING SKIN ON FORWARD SIDE OF LANDING GEAR TRUNNION**

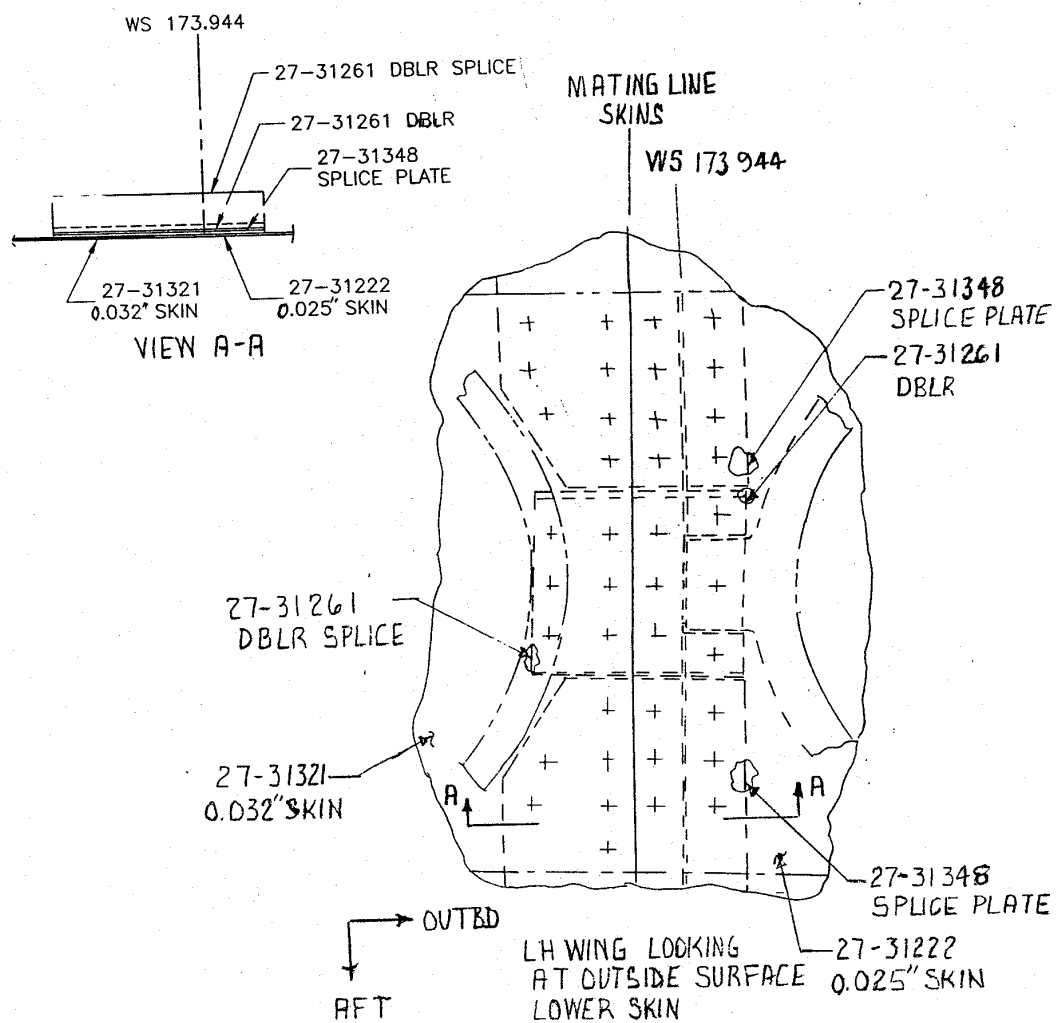
9. Inspect	Easy to inspect directly. Look for fuel leaks.	e	2
Total Score			41

**FIGURE 6-8 W8 - CHORDWISE SKIN SPLICE AT W.S. 173.944  
LOWER SURFACE**

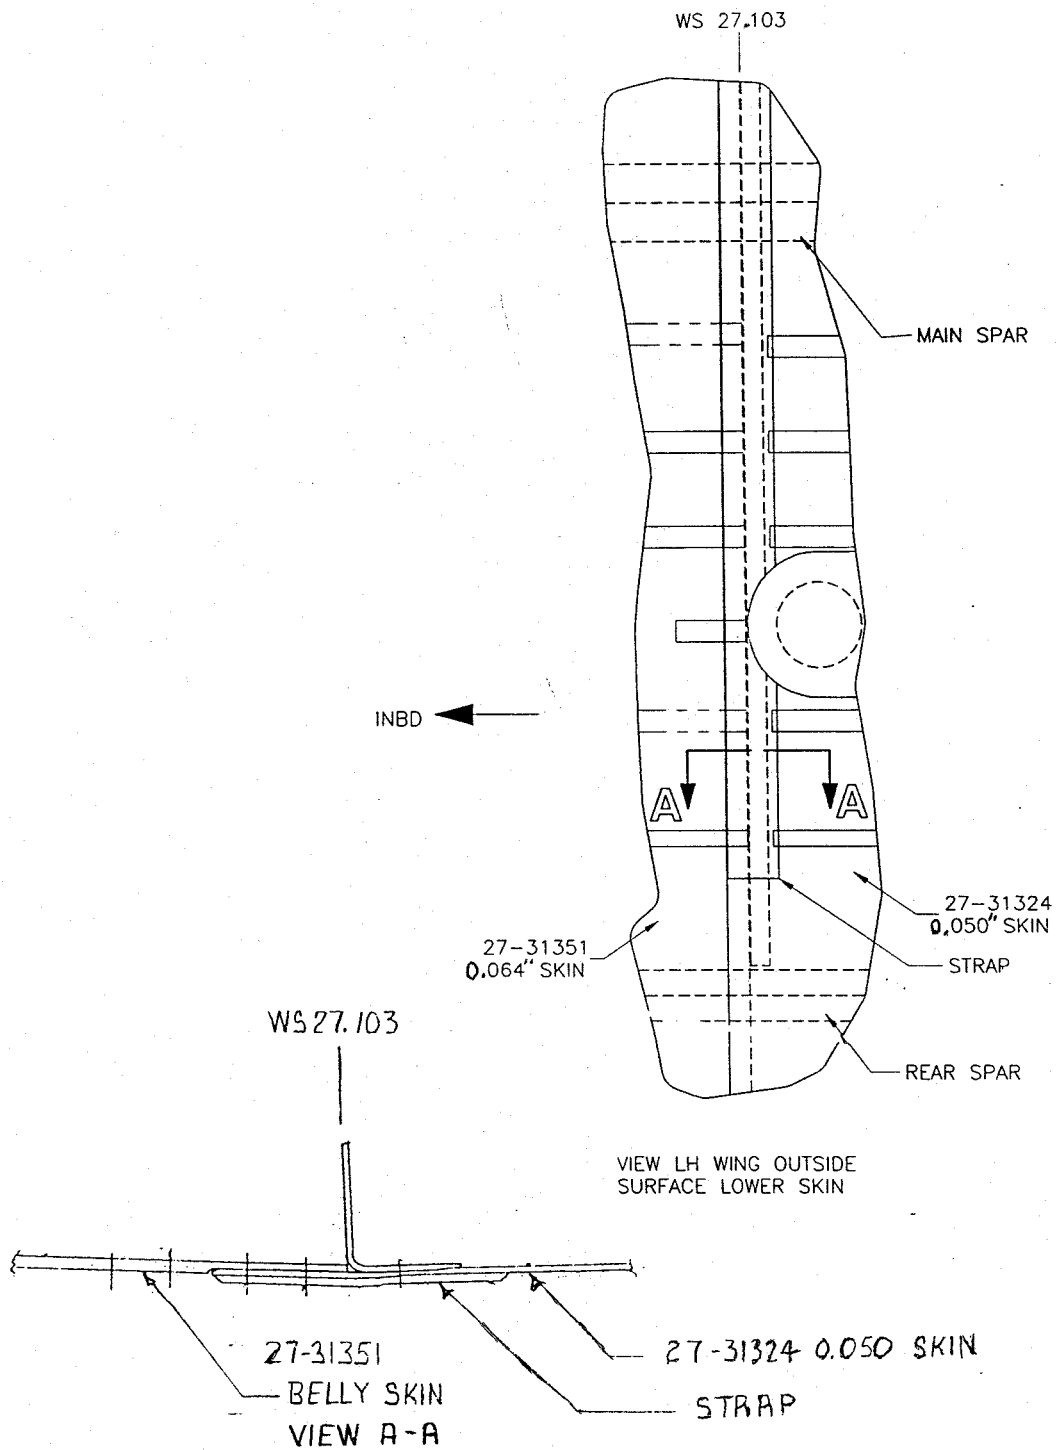
**FIGURE 6-9 W9 - SKIN SPLICE AT W.S. 27.103 LOWER  
SURFACE OUTBOARD OF THE RIB**
